ANNUAL REPORT FOR 2008

**Unnamed Tributaries to Doby Creek Mitigation Site
Mecklenburg County
TIP No. I-3803A**

Prepared By:
Natural Environment Unit & Roadside Environmental Unit
North Carolina Department of Transportation
September 2008

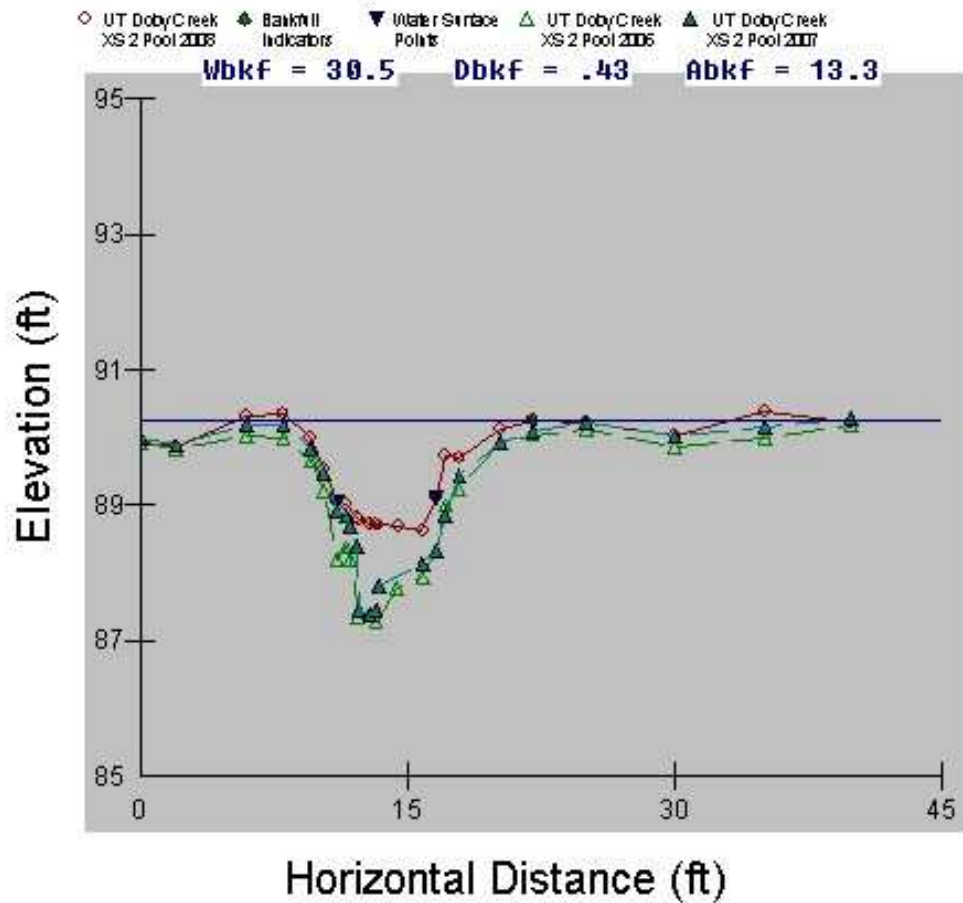
UT Doby Creek XS 2 Pool

Based on comparisons of 2007 to 2008 monitoring data, both cross sections appear stable with little or no active bank erosion. There was some aggradation noted on the graph for cross section #2 pool. This is due to sediment deposited into the channel from a drainage ditch on the fill slope. The drainage ditch has down cut but was stable at the time of monitoring. There was also evidence that a bankfull event had recently occurred on site. Graphs of the cross sections are presented in Appendix A. Future survey data will vary depending on actual location of rod placement and alignment, however, this information should remain similar in appearance.
